**Flood Control Project Maintenance
Levee Inspections****LMA District Cover Sheet****Spring 2011 Levee Inspection Results****Sutter Maintenance Yard Maintenance Area 0016**

Levee Inspection Report By Mile - Spring 2011

Sutter Maintenance Yard Maintenance Area 0016

Waterway						Bank	Unit Miles	Inspection Start/End	Inspector	
Unit No. 01 Feather River						Right	4.09	04/19/2011 04/19/2011	Clay Thomas	
LMR No.	Levee Mile		Category	Item	Location	Rating	Action/Comment	GPS Latitude/Longitude		Issue No.
	Start	End						Start	End	Photo
1	0.01	0.01	Earthen Levee	Animal Control	LS	M	No rodents visible, but rodent burrows visible; need to backfill and compact or grout burrows.	39.255875 ° -121.636398 °	39.255983 ° -121.636417 °	1 Y
2	0.01	4.03	Earthen Levee	Vegetation	WS	A	Control annual grass and weeds on the levee slopes and easements.	39.255929 ° -121.636405 °	39.310494 ° -121.637691 °	9 Y
3	0.01	4.03	Earthen Levee	Vegetation	LS	A	Control annual grass and weeds on the levee slopes and easements.	39.255929 ° -121.636405 °	39.310495 ° -121.637691 °	4 Y
4	0.06	0.10	Earthen Levee	Encroachments	LS	PO	Landscaping	39.256618 ° -121.636442 °	39.257228 ° -121.636462 °	2 Y

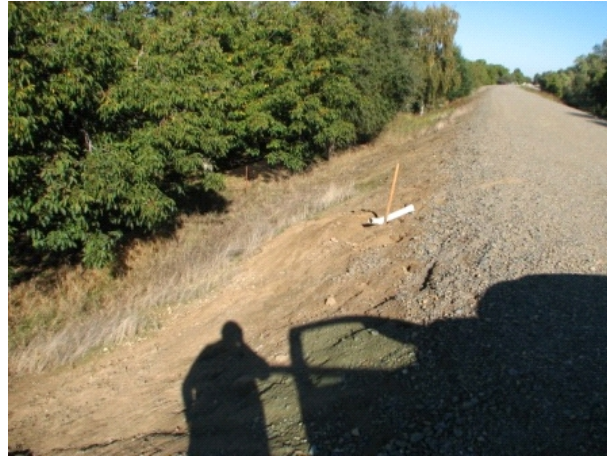
Levee Mile Report Line	1
Start Levee Mile	0.01
End Levee Mile	0.01
Location	Land Side
Category	Earthen Levee
Item	Animal Control

Levee mile 0.01, View of squirrel holes along the slope.

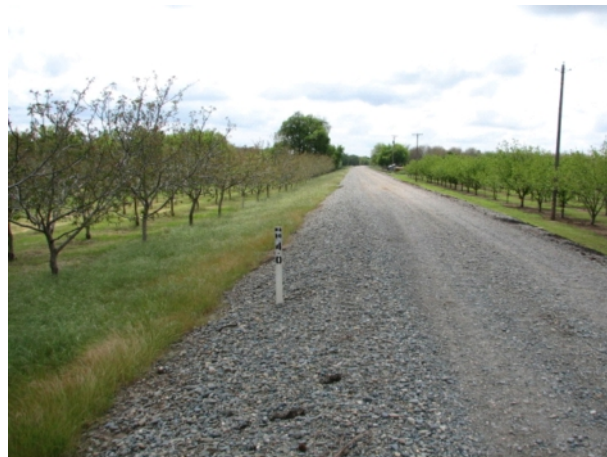
Levee Mile Report Line	2
Start Levee Mile	0.01
End Levee Mile	4.03
Location	Water Side
Category	Earthen Levee
Item	Vegetation

Levee mile 4.04, this photo is looking downstream at the vegetation on the waterside slope.

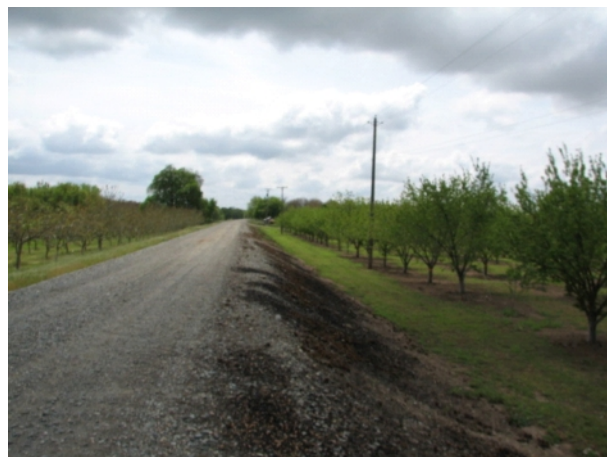
Levee Mile Report Line	3
Start Levee Mile	0.01
End Levee Mile	4.03
Location	Land Side
Category	Earthen Levee
Item	Vegetation

Levee mile 4.04, this photo is looking downstream at the vegetation on the landside slope.

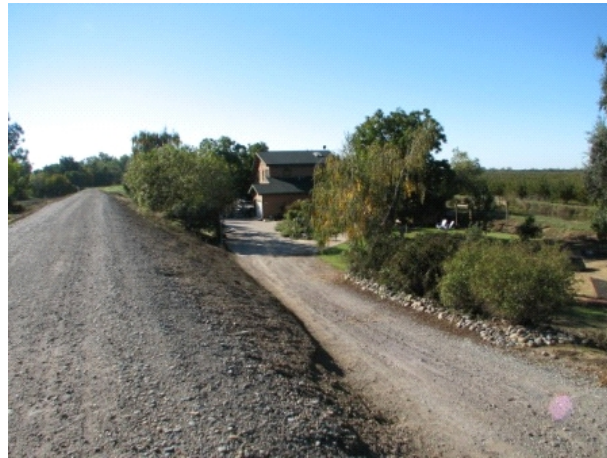
Levee Mile Report Line	4
Start Levee Mile	0.06
End Levee Mile	0.10
Location	Land Side
Category	Earthen Levee
Item	Encroachments

Levee mile 0.10. This photo shows the landscaping on the landside slope and toe.

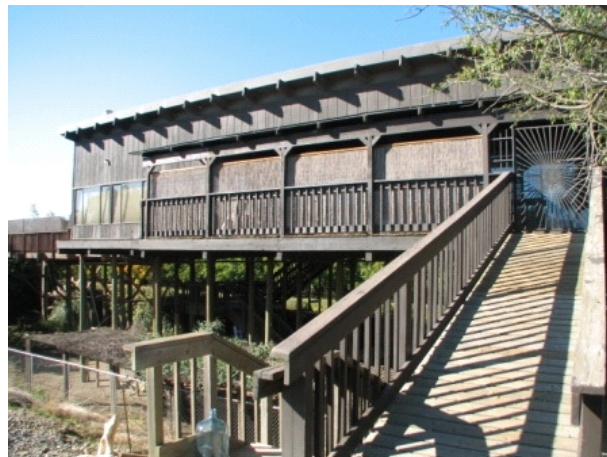
Levee Mile Report Line	5
Start Levee Mile	0.18
End Levee Mile	0.18
Location	Land Side
Category	Earthen Levee
Item	Encroachments

Levee mile 0.18. This photo shows the building on the landside shoulder and toe.

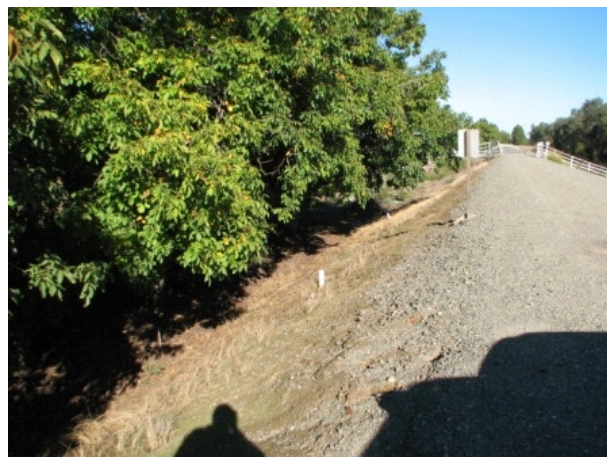
Levee Mile Report Line	6
Start Levee Mile	0.21
End Levee Mile	0.25
Location	Land Side
Category	Earthen Levee
Item	Animal Control

Levee mile 0.21. View of squirrel holes along the slope.

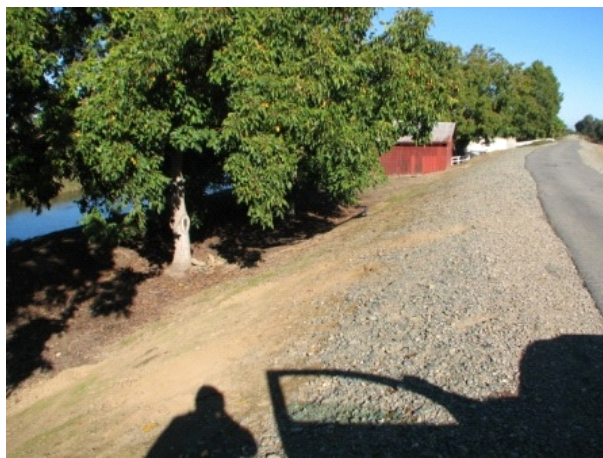
Levee Mile Report Line	7
Start Levee Mile	0.39
End Levee Mile	0.39
Location	Land Side
Category	Earthen Levee
Item	Animal Control

Levee mile 0.39. View of squirrel hole along the slope.

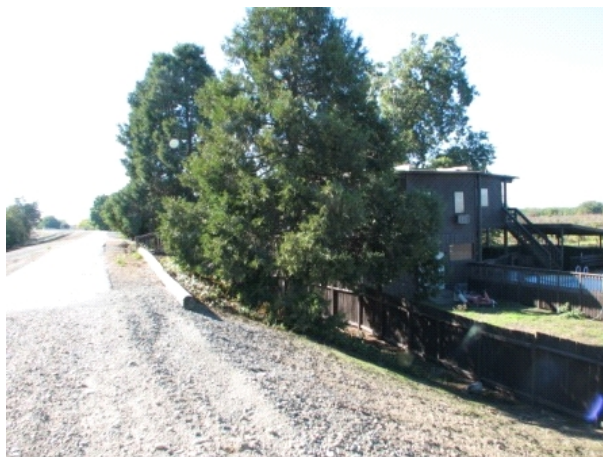
Levee Mile Report Line	8
Start Levee Mile	0.45
End Levee Mile	0.49
Location	Land Side
Category	Earthen Levee
Item	Encroachments

Levee mile 0.49. This photo shows the building and landscaping on the landside slope and toe.

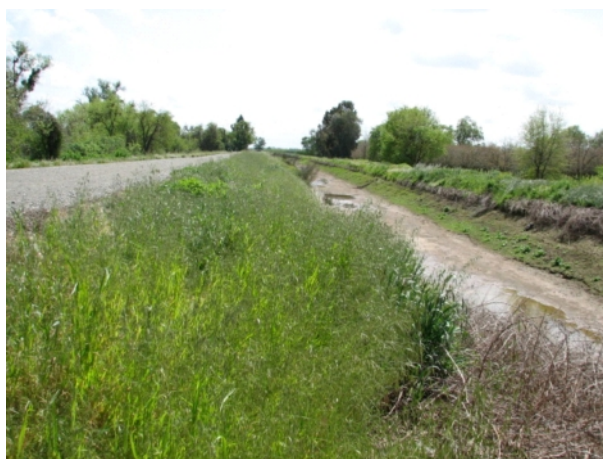
Levee Mile Report Line	11
Start Levee Mile	2.85
End Levee Mile	3.08
Location	Land Side
Category	Earthen Levee
Item	Encroachments

Land side ditch levee mile 3.08.

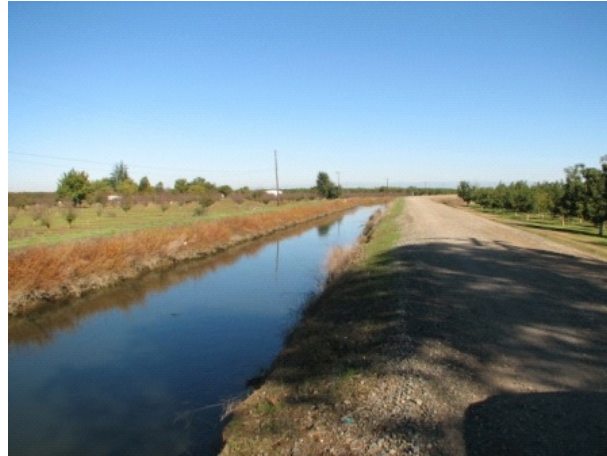
Levee Mile Report Line	11
Start Levee Mile	2.85
End Levee Mile	3.08
Location	Land Side
Category	Earthen Levee
Item	Encroachments

AG ditch land side slope and toe.
